FOKUS ESTONIA

Status: Paper on findings 20220128

ESTONIA'S BOW RAMP DID NOT COME OFF BY ITSELF

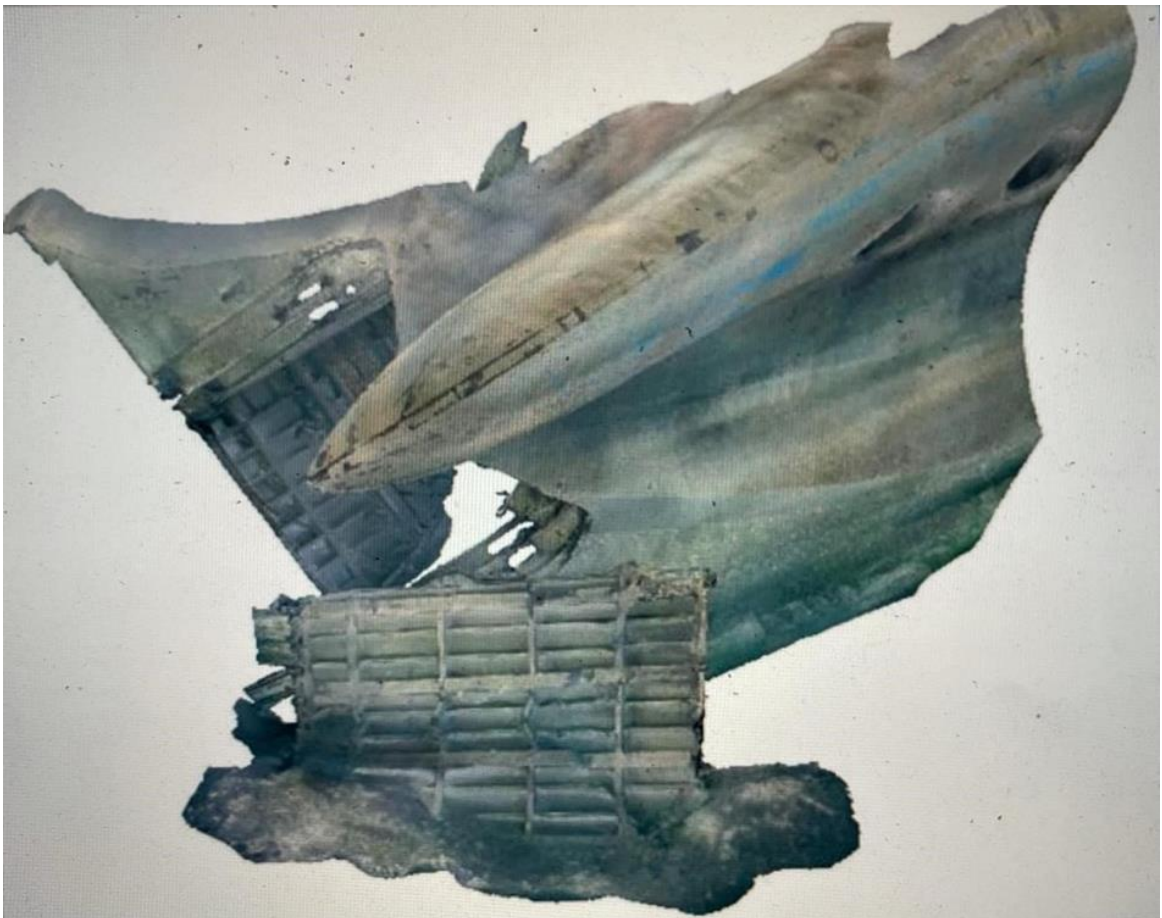
The ramp is seen from below of Estonia. Even the forepeak deck prevents the ramp from spontaneously ending up in the position it is in now. Note that mud/sand covers the outside of the starboard side of the ramp. (Photo from photogrammetry).

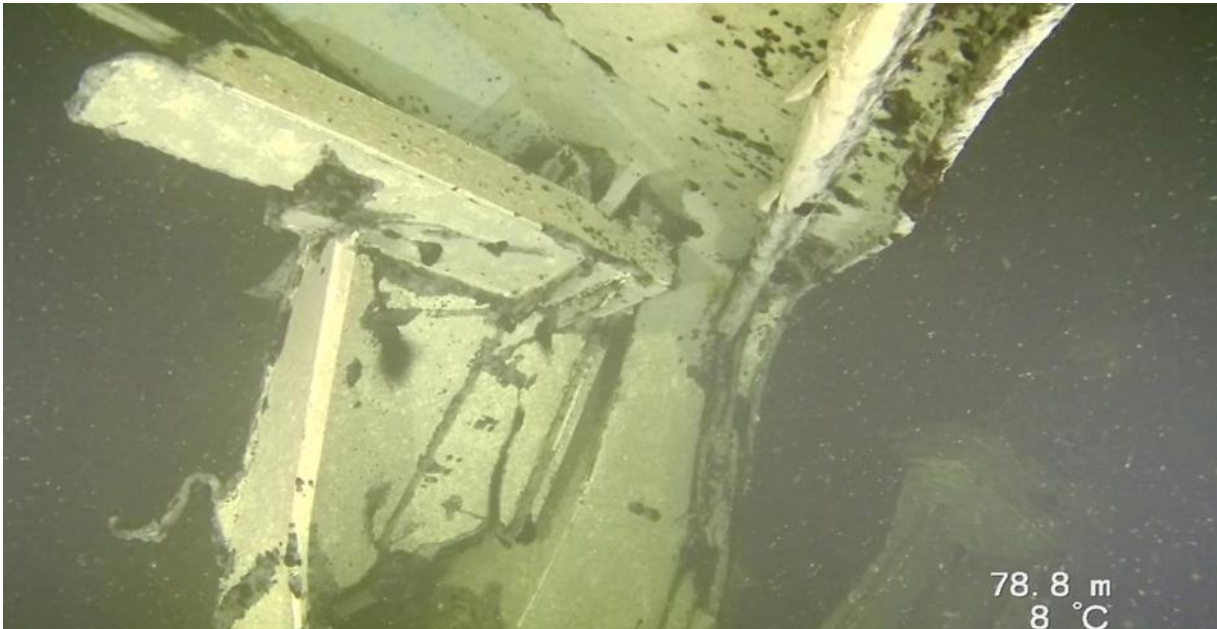
The lower starboard corner of the ramp is still attached with its intact hinge inside the ramp opening and is not corroded. Image from SHK's survey in July 2021.

Below you can see the lower starboard corner of the ramp still attached to the hinge inside the half-metre-deep ramp frame. The ramp has thus not rotated 90° to the right and detached thereafter.

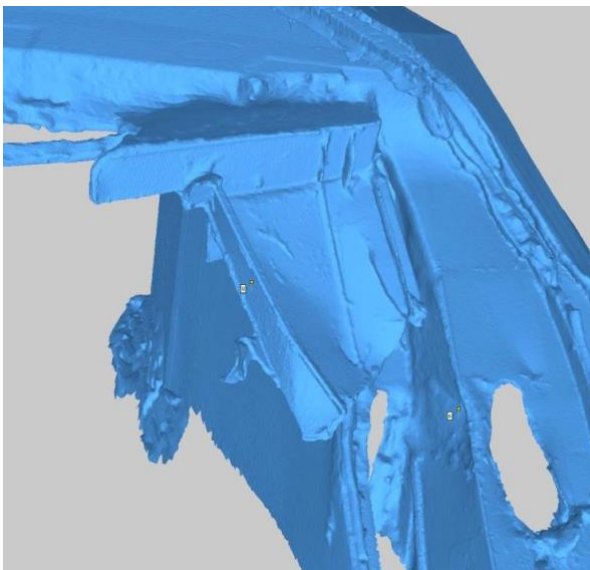
The image of the lower starboard corner of the ramp still attached to the ramp opening is from the photogrammetric 3 D scanning where the paint coating has been filtered out.

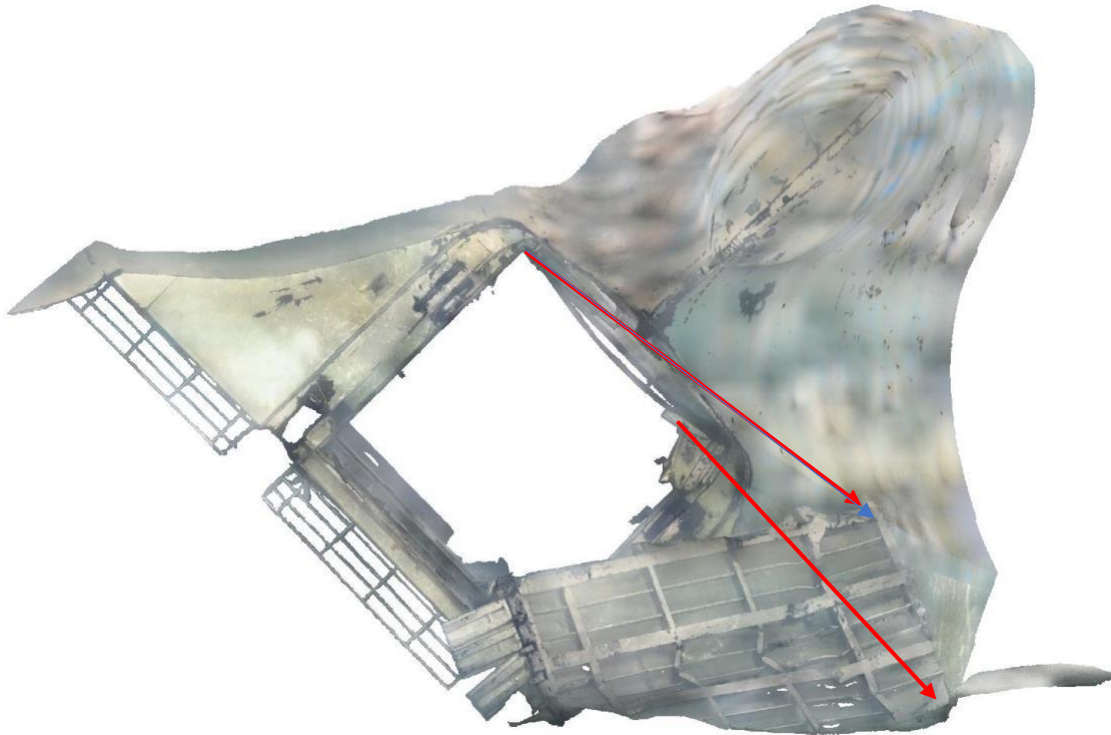
The photogrammetric 3D images below show that the ramp stands 3–5 meters further to the right than it would if it had been spontaneously moved sideways and then fallen straight down.

Photogrammetric orthomosaic of the bow area. The bulb is visible at the top right of the image. The arrows point to the lower corners of the ramp, where the lower arrow indicates the hidden position of the starboard corner. The ramp on the seabed is 3–5 meters further to the right than if it had fallen out by itself.

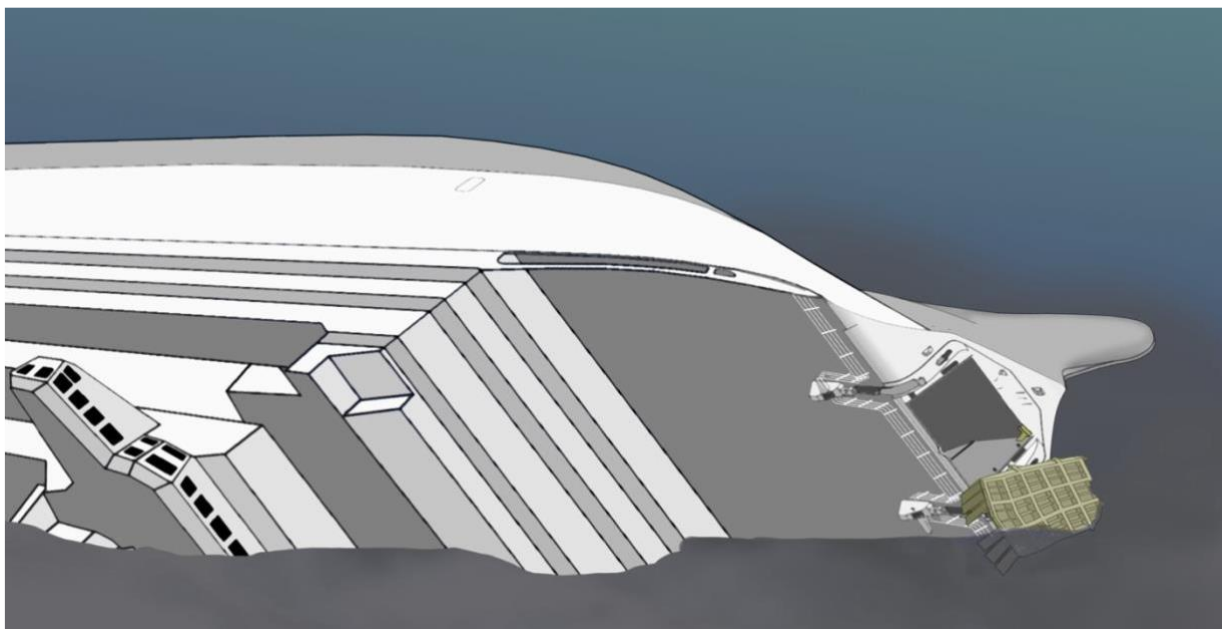
This illustration shows the wreck position schematically at the seabed in 2021, with the ramp resting deep in the sediment and mud. The upper part is obscured by more than two meters of deposit, and the lower part is almost as much. At least one of the flaps that make up the boarding plates is entirely missing; the others on the starboard side are also hidden if they are still in place.

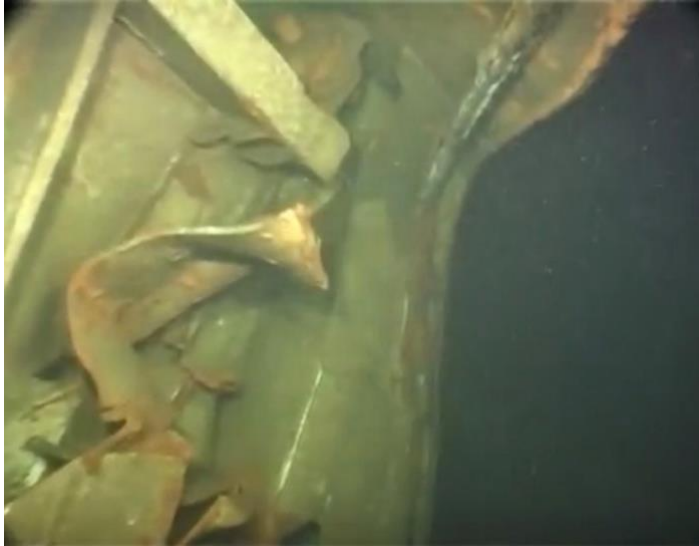
The starboard's lower ramp corner is of particular interest to investigate. As the ramp stands now, it is impossible to examine this corner as sediments and mud cover the corner about two and a half meters up from the seabed. The picture below, taken during the Bemis/Rabe expedition in 2000, shows peculiar damage that was neither commented on nor analysed or explained by the Joint Accident Investigation Commission (JAIC).

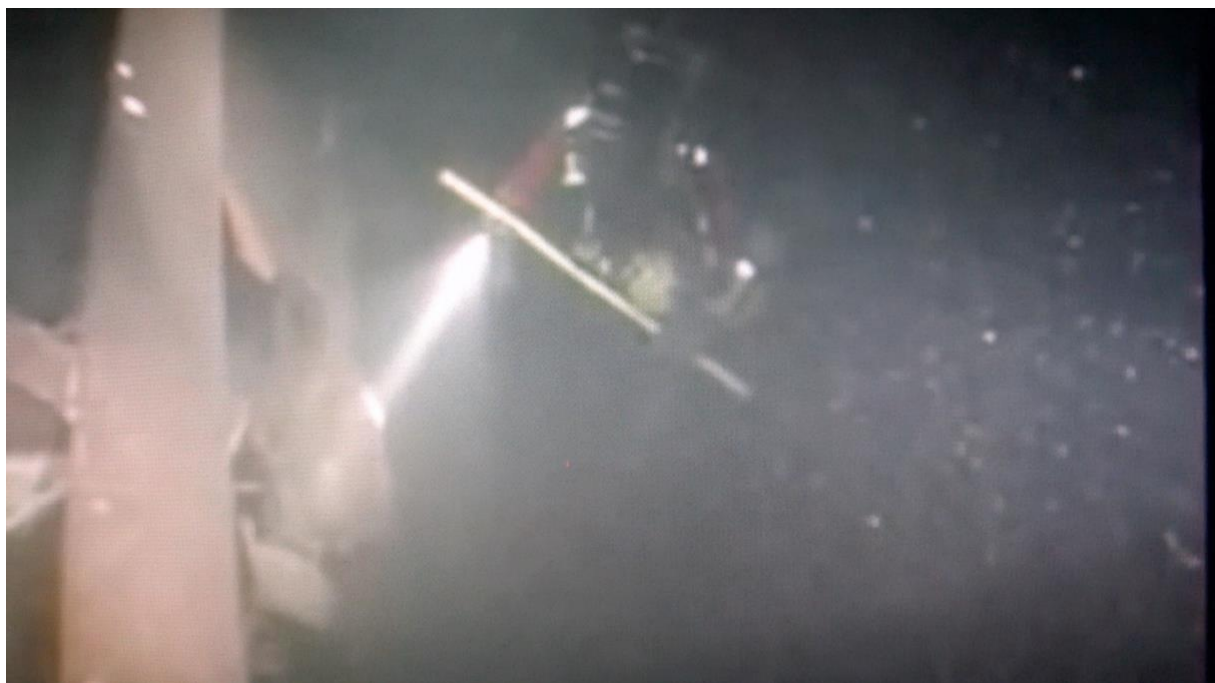
Moreover, the ramp now stands to completely hide the large hole in the starboard forward bulkhead extensively documented by the Bemis/Rabe expedition in 2000. Some of the world's foremost experts on underwater blasts considered that detonations must have caused the hole with its petal-shaped sides. Even this damage was excluded from comments, analysis, or explanation by the JAIC.

In 2000, divers examined the major damage (hole) to the forward bulkhead that is now inaccessible as the ramp hides the damage.
