Metallurgical investigation of a plate from the bow visor from M/S Estonia

Technical Report

I. Westermann

Department of Materials Science and Engineering
Norwegian University of Science and Technology

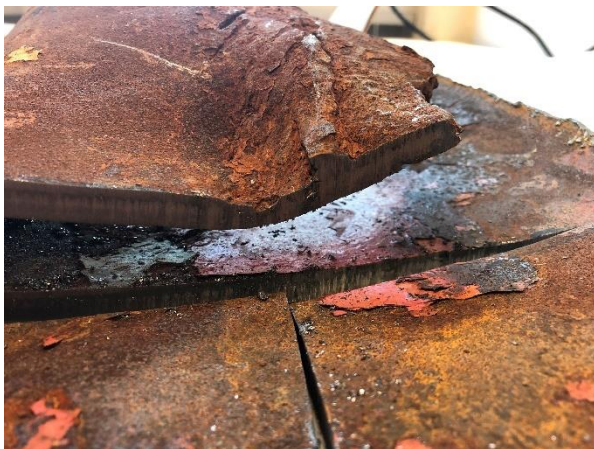
Figure 8 Cross section of the plate in the vicinity of the fracture line (to the right)

One sample was taken in the region next to the reference area towards the fracture line. Figure 8 shows the cross section of the plate where the sample has been taken. Also note the grooves observed at the top of the photo. This region shows a thinning of the plate approximately 6 cm from the fracture surface. The thickness in this region was measured to be 5 mm. Parallel to the fracture line a thicker region is observed, comparable to a ridge of metal that has been pushed up from the thinner area. The total height of the ridge is measured to be in the magnitude of 15 mm. The fracture has occurred in a distance of approximately 30 mm from this ridge. A slightly thicker rust scale is observed from the thin region and towards the fracture line.

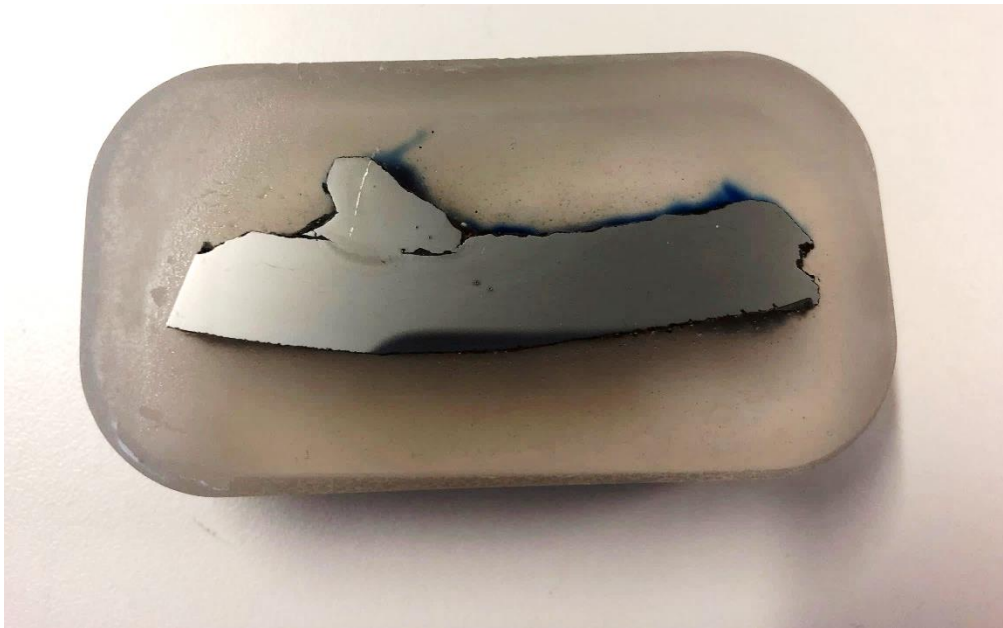
Figure 9 the metallographic prepared cross section of the sample.

Figure 9 shows the cross section of the plate after metallographic preparation and etching. The fracture to the right shows necking and a ductile behavior. The ridge seems to be material that has been pushed up and metallographic bonded with a fine grained region in the middle and a region on both sides of this, where a surface area have been enclosed inside the material.

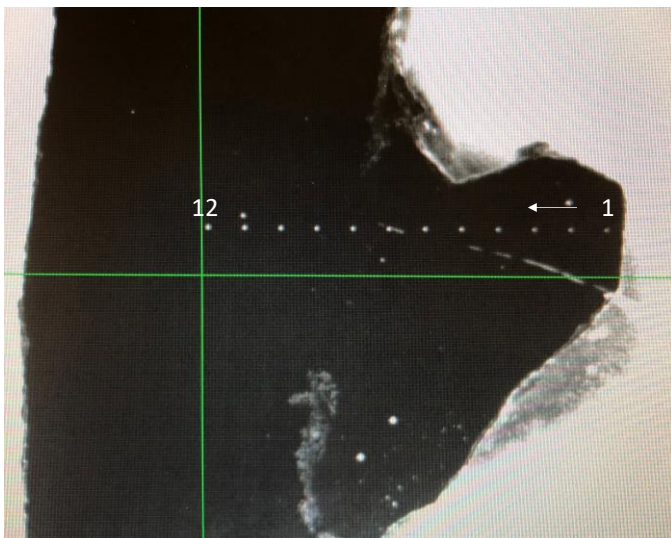
Figure 10 Hardness measurements were conducted in a line from right to left.

Vickers hardness measurements were conducted from the top of the ridge towards the center of the of the plate, see Figure 10 and Table 1. The hardness was found to be HV 286 at the top point of the ridge and descending through the ridge. A slight increase is seen in the fine grained region (points 7-9) and then decreasing again to the expected hardness of the plate. The first point (HV 286) at the outermost surface is assumed to be a martensitic structure.

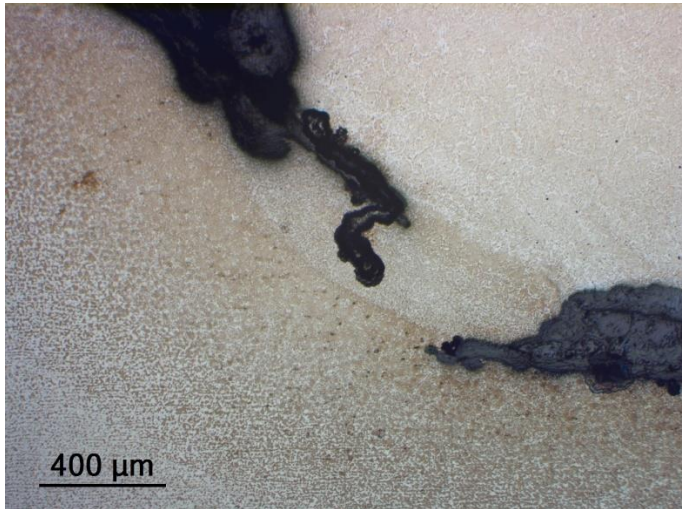
Figure 11 Joint region between the ridge cap and the base plate material.

The variation in microstructure across the interface is clearly visible in Figure 11, where the ferritic/pearlitic structure is visible in the bottom left corner, the pearlite becomes coarser and then a very fine grained structure is observed in the middle. In the upper right region a ferritic pearlitic region with ferrite along former austenitic grain boundaries, see Figure 12, is observed with a pearlitic interior. The former austenite grain size is in the order of 100 μm .

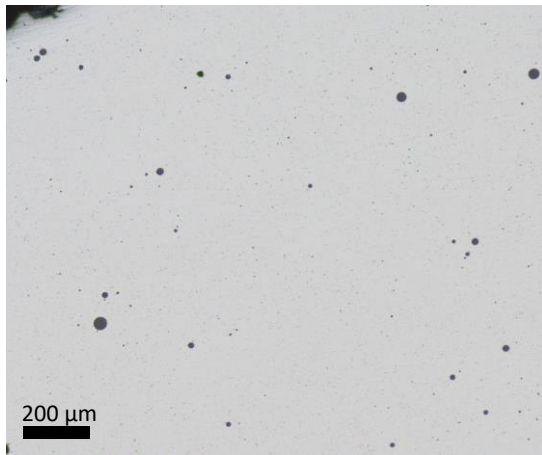
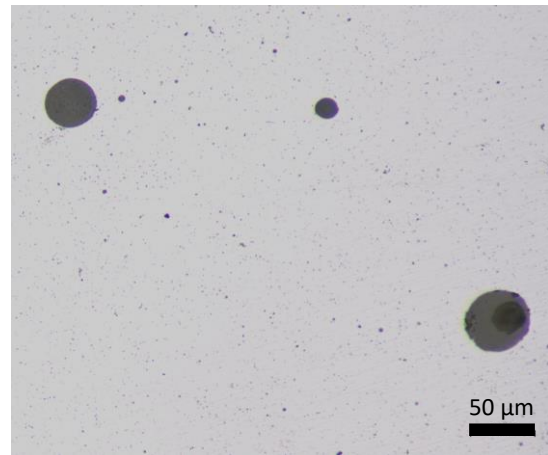
Figure 13 Different magnifications of spherical phases in the ridge cap material.

In the ridge cap a high amount of spherical black phases were observed as seen in Figure 13. There was a large variation in size, where the largest were in the size range of 50 μm in diameter. Figure 14 shows how the particles are randomly distributed in the microstructure.

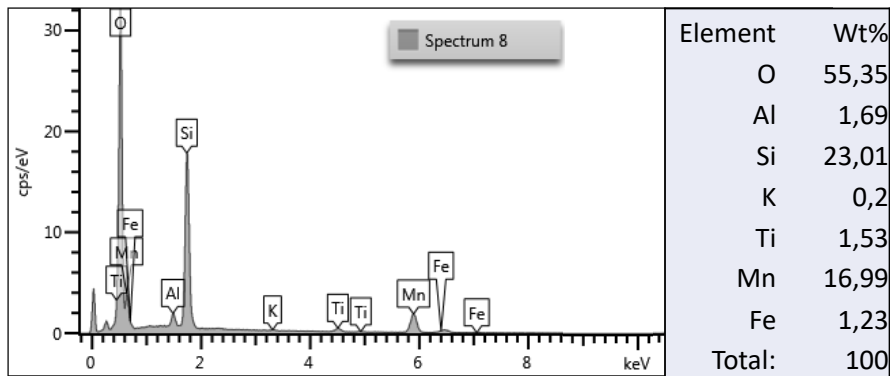
Figure 16 Element analysis of the large particle in Figure 15 (Spectrum 8)

Both the particles contain a large amount of Mn, Si and O. Spectrum 9 also indicates Fe, but since the particle is small, the surrounding matrix may contribute to the signal and should be considered a source of error. Small amounts of K and S are also detected. The K peak is very low, but the S peak in Figure 17 is significant. All elements are typical elements that can occur from production process of the steel. However, the Mn and Si levels are significantly high, and it is difficult to point to a specific source for such high levels of the elements. Mn and Si are often used as deoxidizer in welding filler wire, but from the macroscopic appearance of the plate with the thinning and the ridge it is difficult to see how the ridge would have been added as extra material. The thinning and ridge share similarities with features seen in explosion welding.

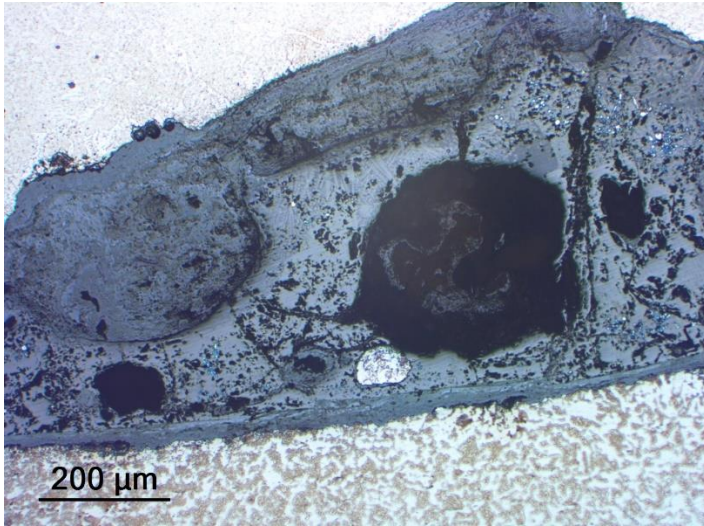
Figure 18 Light optical micrograph of the intermetallic region between ridge cap and base material

Figure 18 shows the light optical micrograph of the intermetallic regions between the ridge cap (top) and the base plate material (bottom). The intermetallic phase is porous and appears in different grey tones with some smaller white spots of steel phases. Attention should be drawn to the microstructure in the center region. A close up at higher magnification is shown in Figure 19.

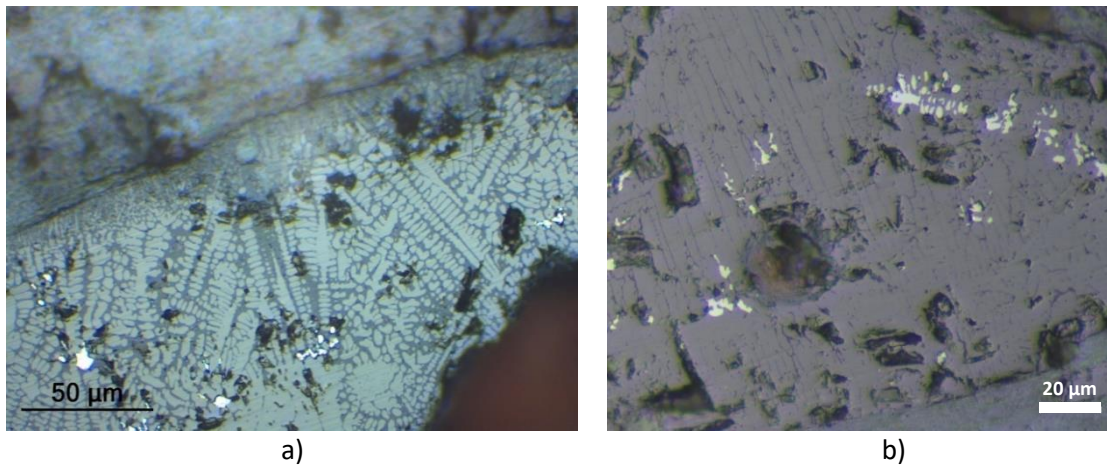
In Figure 19a, a dendritic microstructure is observed. This is a clear indication that the intermetallic phase has been in a liquid melted state and has solidified. Figure 19b shows the unetched microstructure from another place in the intermetallic region. Here, the bright spots show tendencies of dendritic growth, whereas the surrounding grey region shows a cellular directed growth, where the grains are of $\sim 5 \mu\text{m}$ widths and in the range of $100 \mu\text{m}$ length. Indications of dendritic character are seen occasionally along the boundary. This indicates that the solidification rate of this grey phase has been so slow that cellular structure and not dendritic structure has formed.

Figure 19 a) Dendritic growth in the intermetallic phase, b) the unetched microstructure showing cellular growth in the intermetallic phase.

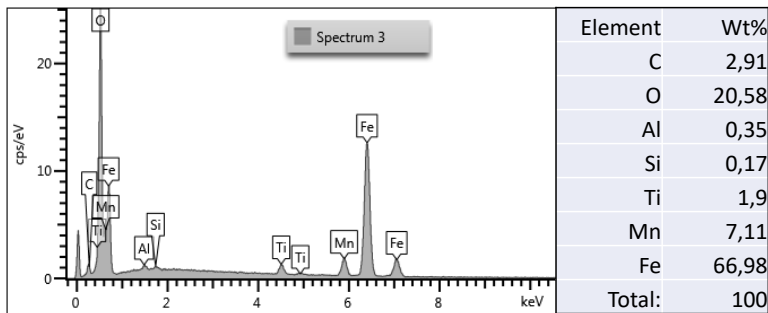
Figure 21 The EDS spectrum from the dendritic structure in Spectrum 3 in Figure 21.

EDS analysis from the dendritic phase, e.g. spectrum 1 and 3 in Figure 20, reveals that the phase contains the amount of elements according the table listed in Figure 21. Fe, O, Mn and C are the main elements in this phase. O and C is usually difficult to quantify by EDS, but it is reasonable to believe that the elements are present within in the phase. It is reasonable to believe that this is melted iron oxide, and the temperature is estimated to be above $1200 \text{ }^\circ\text{C}$.

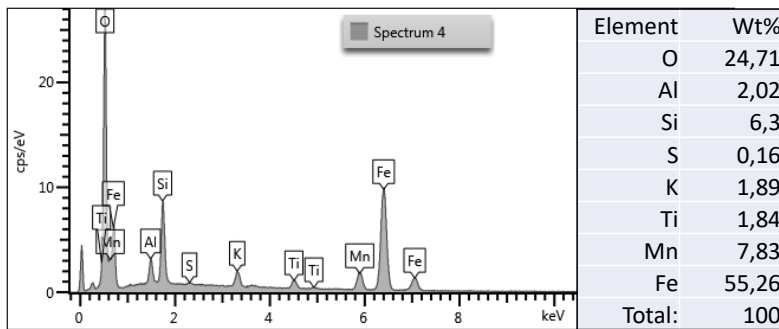
Figure 22 The EDS spectrum from the eutectic structure in Spectrum 4 in Figure 21.

The EDS spectrum from the eutectic region is shown in Figure 22. In addition to iron, oxygen and manganese, there is a higher level of Al and Si compared to the dendritic phase, as well as traces of S and K. Both S, K, Si, and Ti are elements that have been found in several of the paint systems, cf. reference 1, p. 9.

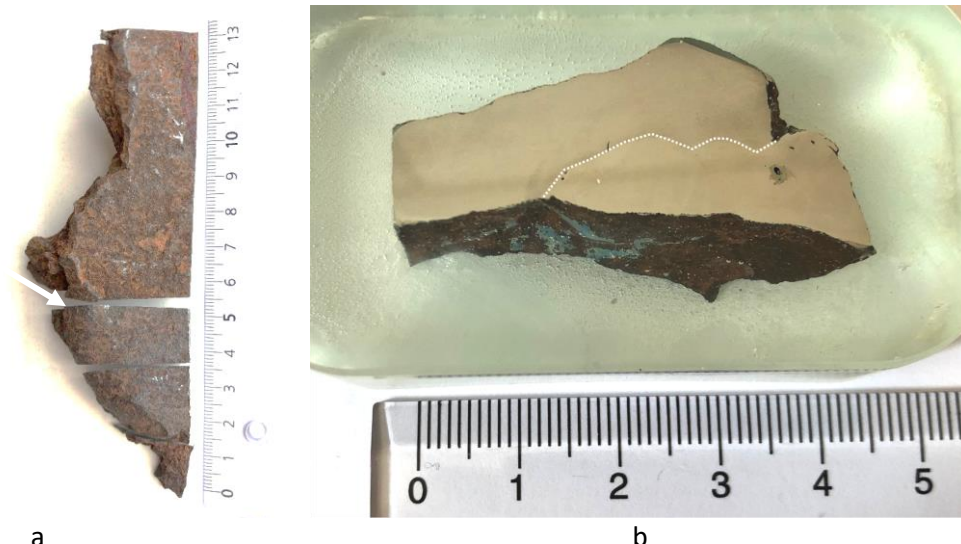
Figure 23 The region with an increased thickness. A) the arrow indicates where the cross section shown in b) is taken from.

Two different samples were taken from the fracture area of the plate, where a clear thickening is observed. Figure 23 a) shows the piece that was cut from the plate, cf. Figure 3. The arrow indicates the cross section of interest shown in Figure 23 b). From Figure 23 a) it is seen that the fracture line in this region is complex with areas with a rough fracture and regions where the fracture is completely smooth.

The area of interest in Figure 23 shows the etched surface. The white broken line indicates what could be a weld line. The primary reason for this assumption is that the blue paint on the back side seems to be continuous over the region. At maximum the sample here is 18 mm thick, and the length from the weld line to the tip of the fracture is 3 cm. The plate is at the top, above the weld line and the weld material underneath, this means the heat source has been from the other side compared to sample one. The fracture seems to be twofold, a vertical part above the broken line, and a 55° inclined ductile fracture at the lower part. The deformation direction of the microstructure at the fracture shows that the grains are elongated in a downwards direction, meaning that the plate must have been pushed up in the visor, opposite direction as the bend, from its original position. At the top of the sample there is a flat region, this can also be seen in Figure 23 a), where the microstructure shows a thin deformed layer, ~1 mm thick. Six larger pores are observed in this cross section, three in the vicinity to the weld line and three in the bulk material. Two of these are in the size range of 1 mm and were investigated in SEM and are shown Figure 24. The large pore in Figure 24 a) is 873 μm in maximum feret diameter and is seen as the large pore to the right in Figure 23 b). The elongated pore in Figure 24 b) is 970 μm long. In Figure 23 b) this is the vertical pore observed right above the dotted line to the left (it may also be seen in Figure 26 at the arrowhead). Nonconductive “threads” with a diameter 5-10 μm , Figure 25, were found inside these two pores. It is assumed that these are metal oxides. None of the other pores revealed similar findings. EDS results from these threads were difficult to interpret due to the charging of the region. The porosity in Figure 24 a) might be connected to the free surface enabling oxidation, but the elongated pore in Figure 24 b) is located in the very bulk material and it is, hence, unlikely that it extends to the surface.

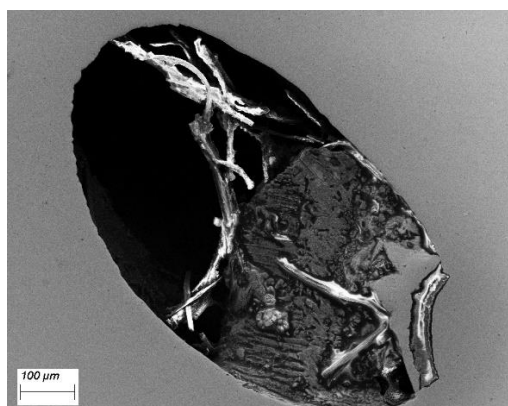
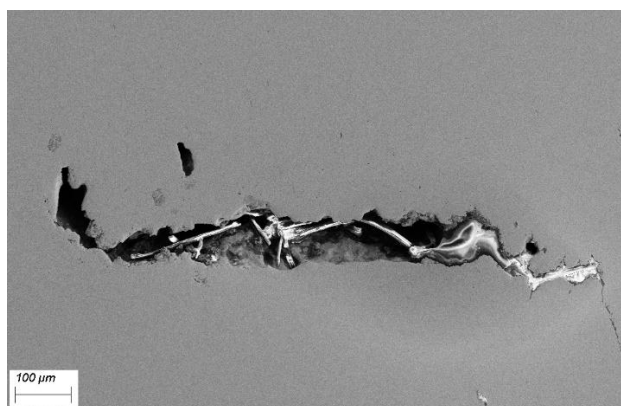
Figure 24 Large porosities in sample 2 with metal oxide threads inside.

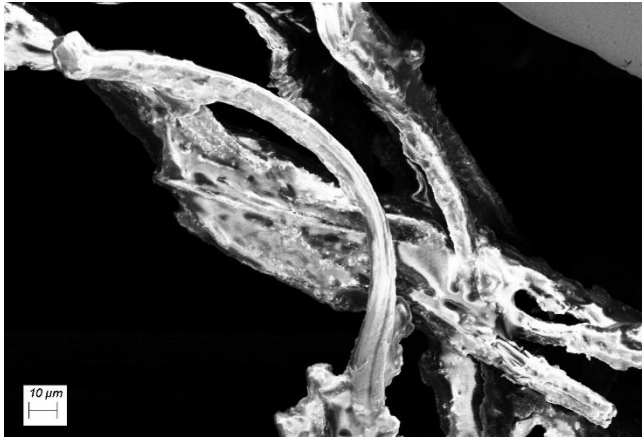
Figure 25 Close up of the metal oxides found in the pore in Figure 24 a).

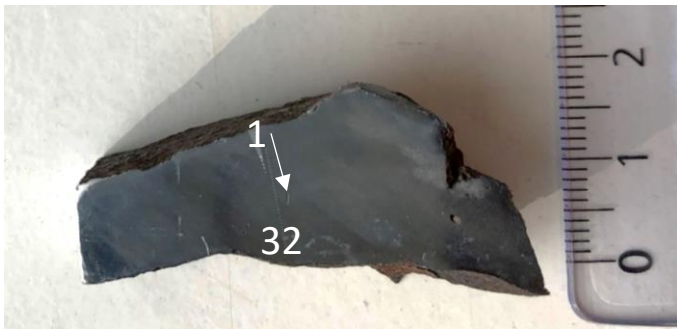
Figure 26 Indication of the hardness measurements across the interface of sample 2.

Hardness measurements were conducted according to Figure 26 and are listed in Table 2. In the upper part (measurement 1-17) of the sample where a ferritic/pearlitic microstructure is found, the average hardness was found to be HV 164. When entering the lower region the hardness increased to HV 200.

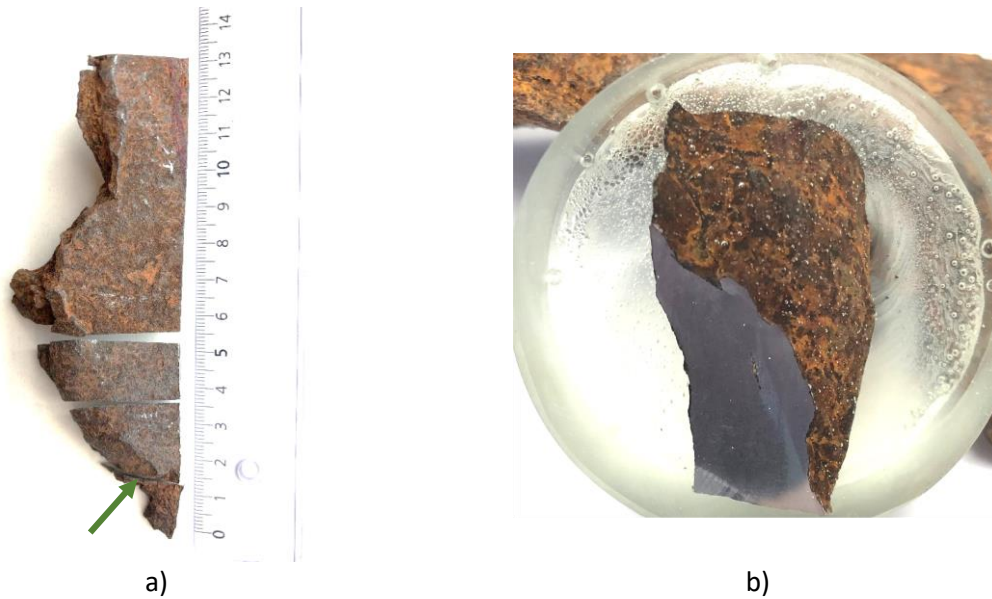
Figure 27 Sample 3 is taken from a region where the fracture surface is almost smooth.

Sample 3 is taken from a region of the fracture line where the fracture was almost completely smooth, as seen in Figure 27. In Figure 27 b) the sample has been slightly inclined to give an idea of the surface topography. The macroscopic appearance of the fracture surface is difficult to assign a brittle or ductile mode.

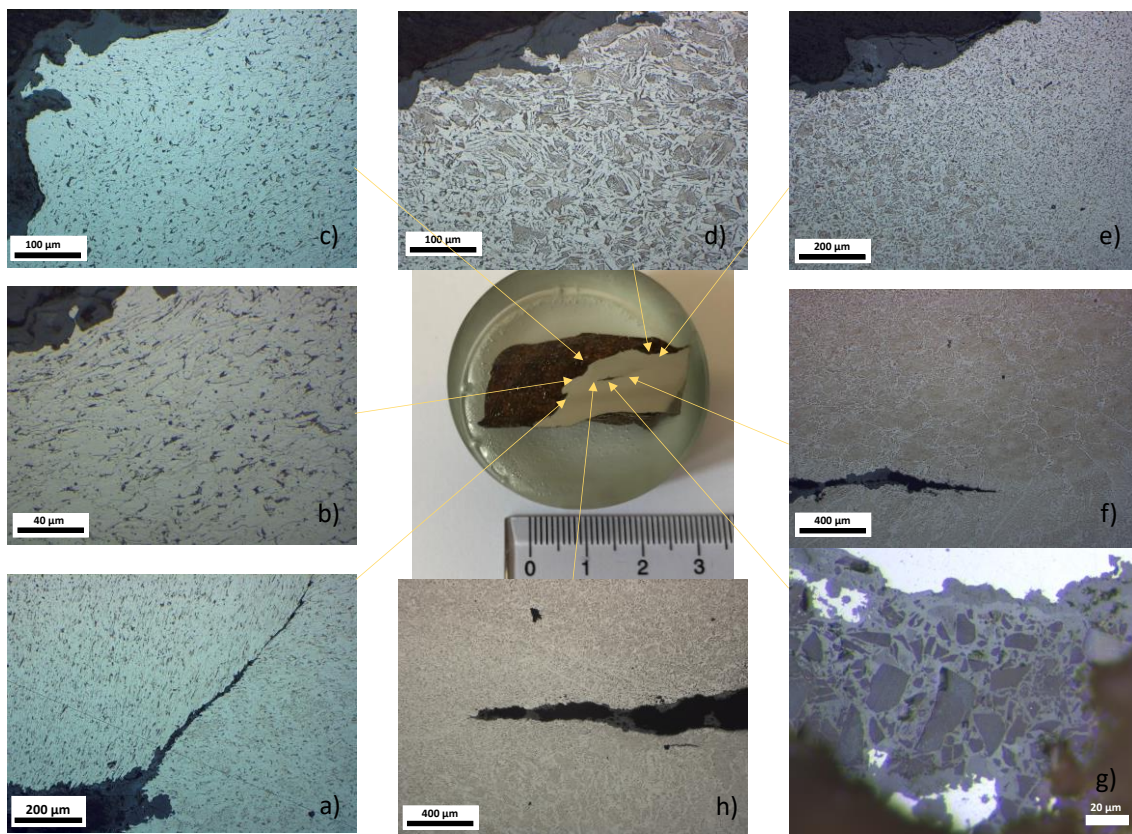
Figure 28 An overview of the regions where the different microstructures are found.

The microstructure in this sample is extremely complex. Figure 28 shows from where in the sample the microstructure is found, and Figure 29 shows the larger micrographs. Inside the sample there is a larger pore of 5 mm length that contains intermetallic phases, and it is reasonable to believe that the smeared-out microstructure and fracture appearance has occurred when the plate was bend.

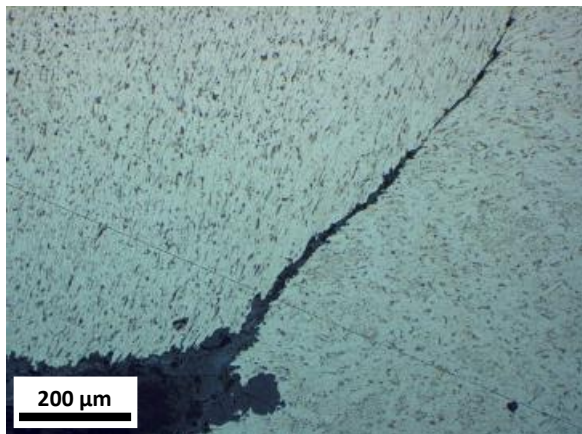
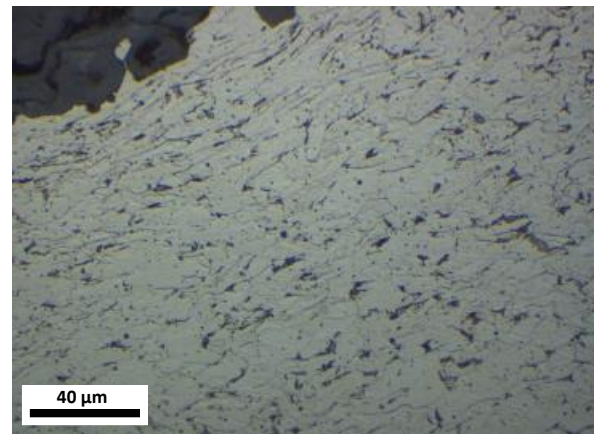
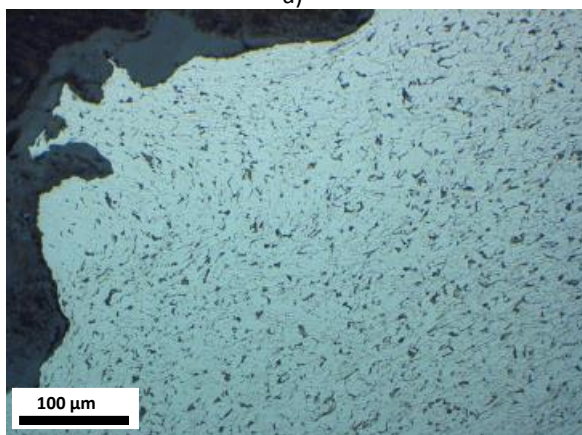
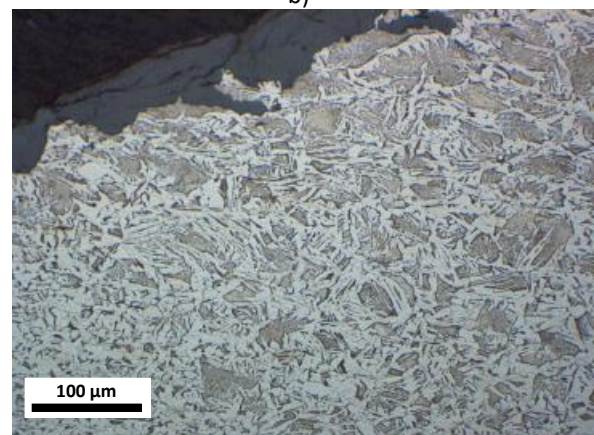
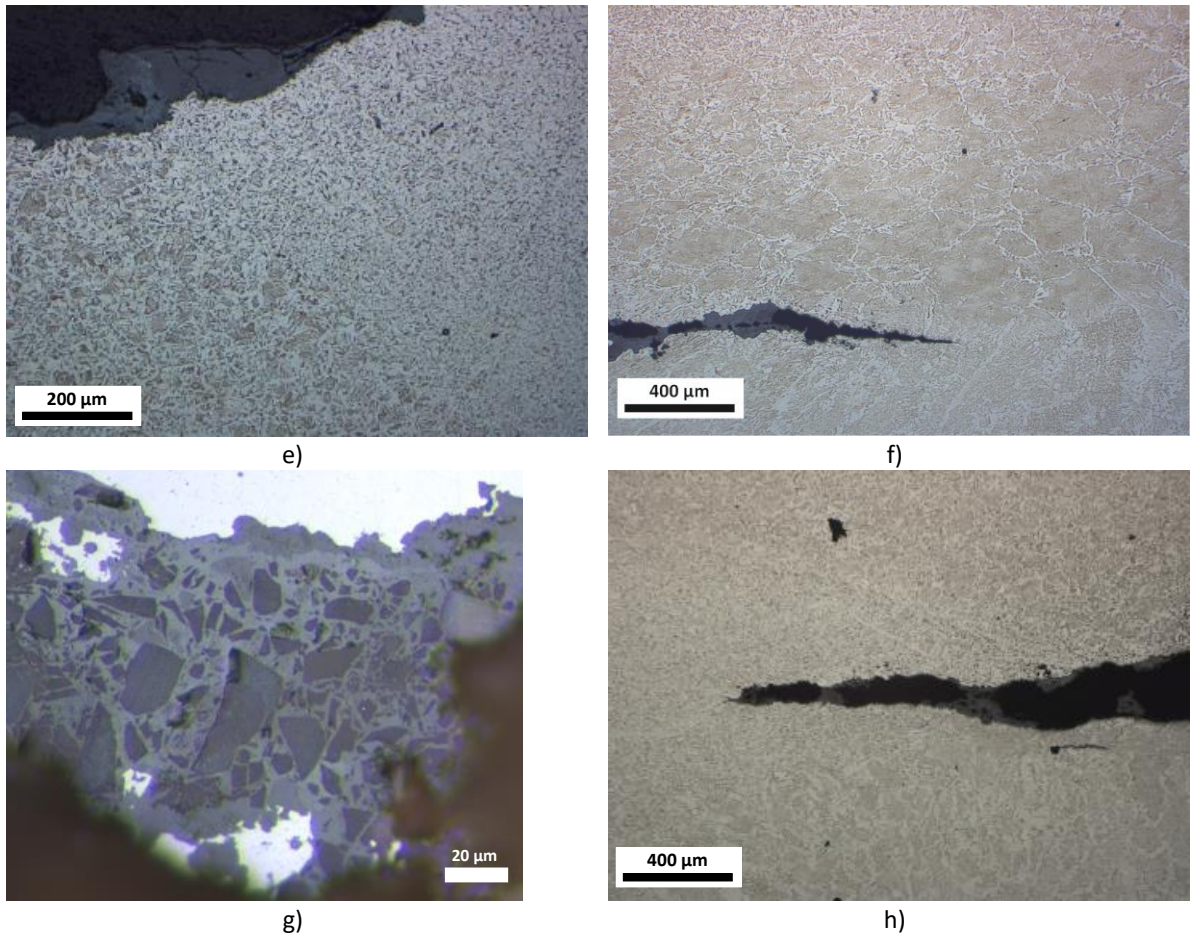
Figure 29 Larger micrographs of the microstructures in Figure 28.

Figure 29 show larger micrographs of the different microstructures. In a) a crack is shown from the part of the fracture surface where it is believed that two different materials (two plates) have been smeared together. It is likely that the kissing surfaces seen in a) are the surfaces that extends to the

pore/crack in the interior. The microstructure consists of very fine-grained elongated ferrite and spheroidized pearlite. Deformed ferrite is also observed in (b). The pearlite has been spheroidized into finely dispersed carbides. Spheroidization typically occurs in the temperature range 440°C - 750°C. This is in contrast to the more normal, but deformed, ferritic/pearlitic microstructure in (c) where the size of the pearlitic grains is comparable to the reference material. Oxide/rust is observed along the fracture in Figures 29 a)-e). In figures (d) and (e) large variations from the normal structure is observed along the fracture surface. In (d) a pearlitic structure with Widmanstätten ferrite is seen. This indicates that the microstructure has been heated above A_3 and cooled with a rather high cooling rate to obtain the Widmanstätten structure. The former austenite grain size is in the range 50-100 μm . In (e) the rapid change in microstructure from coarse to finer grains along the fracture surface is observed. A coarse Widmanstätten grain structure is detrimental for the fracture toughness, but it is difficult to say when this transformation occurred, if it was prior to or in connection to the failure. The tips of the pore/crack are shown in (f) and (h). There is a difference in the adjacent microstructure from the crack tip closest to the fracture, (h), or further away from the fracture, (f). In (f) a very fine lamellar pearlite with ferrite bands indicating former austenite grains. Some fine Widmanstätten ferrite is also observed. Noticeable is the size of the former austenite grains which are up to several hundred micrometers in length. Inside the pore/crack large regions with oxides and intermetallic phases were observed. In (g) such a region is shown, where pointy and angular shaped dark grey intermetallic phases are observed in a lighter grey matrix. Some of the dark grey phases seems to have cracked in a brittle manner.

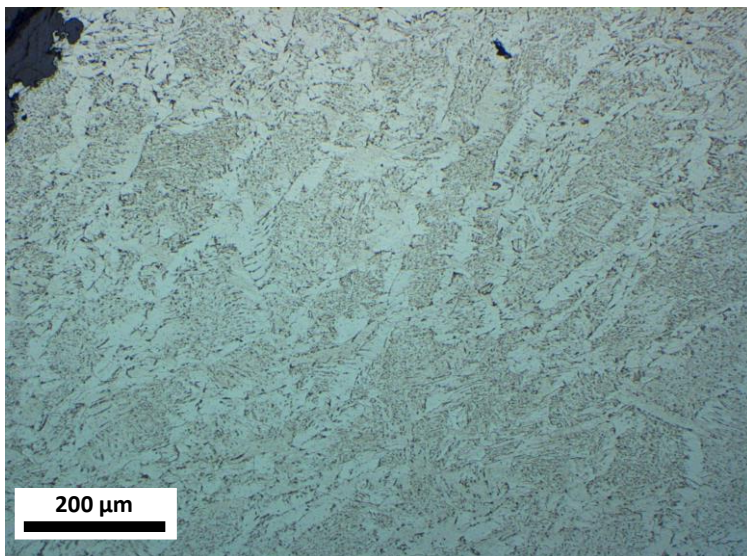
Figure 30 The microstructure in the pointiest part of the fracture

The material underneath the pore/crack seems less affected than the upper part. But as seen from Figure 30, which is from the outermost pointy part of the fracture, the microstructure shows large and elongated grains where the cementite rich part is surrounded by ferrite and some Widmanstätten ferrite is also observed here.
