Metallurgical investigation of a plate from the bow visor from M/S Estonia

Technical Report

I. Westermann

Department of Materials Science and Engineering
Norwegian University of Science and Technology

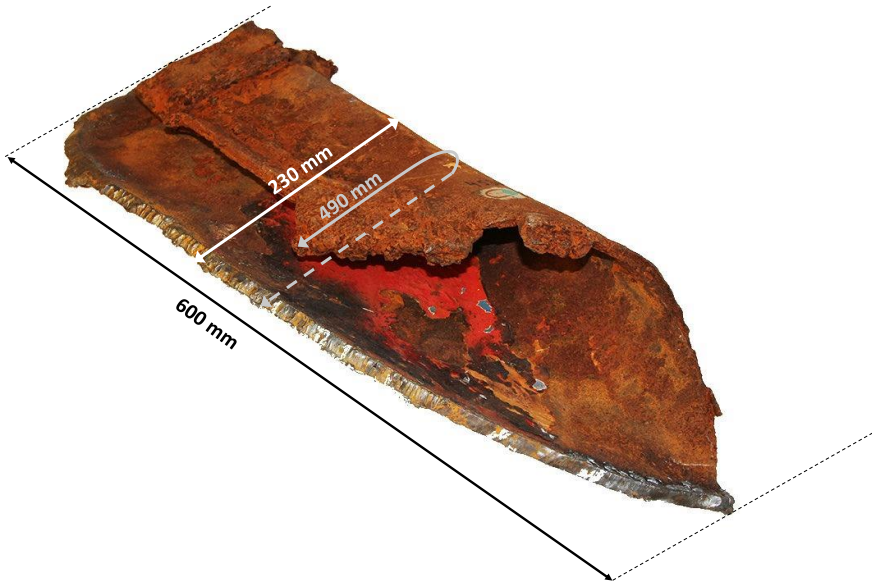
Figure 1 Measures of the plate of interest

The received plate has been cut from the bottom side of the visor and is marked #4536. The plate is 600 mm long and the piece is curved and on the widest 230 mm wide, as shown in Figure 1. The total plate width, unfolded, is 490 mm on the widest. Figure 2 shows the bow visor and indicates where the plate has been removed from, note that the plate has been bend outwards according to how it is shown in Figure 1. The bow visor was raised on the 18th of November 1994, 52 days after the sinking¹. It was according to the JAIC report first moved to Finland and later moved to Muskö Örlogsbas where it has been stored under roof. It is unsure when the plate was removed from the visor, but is expected to have occurred in relation to the official accident investigation. To the left in Figure 3, a butt weld is observed that runs perpendicular to the bend. The weld is fractured in the bend region. Some paint is left in some regions, where both red, blue and white is observed, but the majority of the plate is rusty. Some of the paint observed to the right in Figure 3 seem black and burned, but this, however, is expected to come from the cutting. The cut edge is further out on the backside of the bend plate in Figure 3. The upper side contains the fracture that has occurred in connection to the bending. The fracture line has a mixed mode of both clear edges and rough, thick and smooth surface fracture – in general very complex fracture. Two grooves are observed on top of the plate in the region where there is a general thickening of the plate (these are also observed in Figure 8). The plate was, in the less affected region (the cut out square in Figure 3), measured to be 10.6 mm thick. Focus in the investigation has been on the upper side of the plate, and in a region ~10 to 35 cm distance from the butt weld along the fracture line. Figure 4 shows the backside of the plate near the butt weld. None of the investigated samples are taken from an area influenced by this perpendicular weld. It is, however, unsure what the adjacent region parallel to the fracture line has been exposed to.

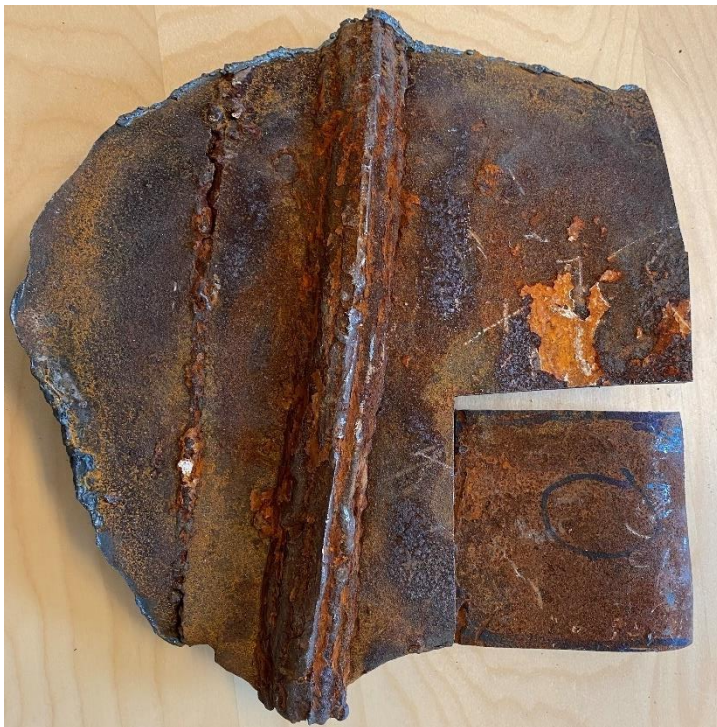
Figure 4 Backside of the plate showing the butt weld and the weld region. Samples are not directly located in the vicinity of any welds.

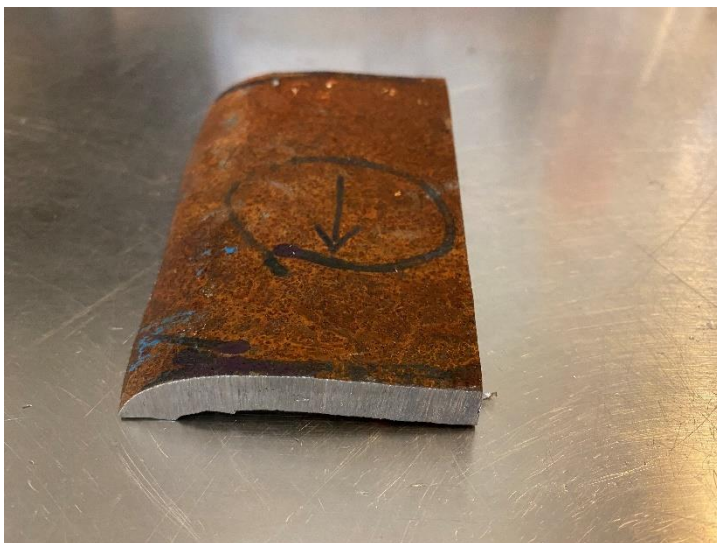
The sample in the unaffected region was cut from the sample shown in Figure 5 where the microstructure in the cross section at the tip of the arrow was investigated.

Figure 5 The sample from the unaffected region was taken from the cross section that the arrow points to.

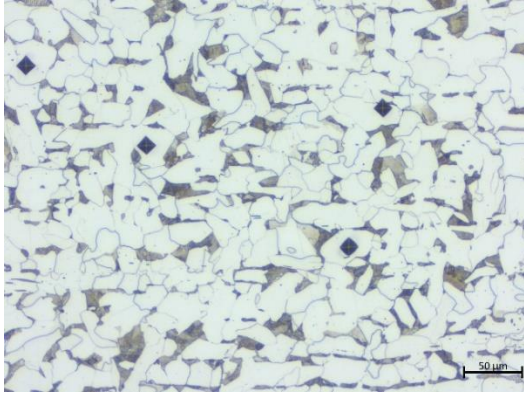
The microstructure, shown in Figure 6 and 7, reveals a ferritic/pearlitic microstructure with a grain size of approximately 15 μm . Microhardness indentations in the ferrite and the pearlite show a hardness of HVM 178 and HVM 242, respectively. This is the microstructure that is expected for a mild steel.

Figure 6 Ferritic/pearlitic microstructure. Microhardness indentations are seen in the ferritic grains.

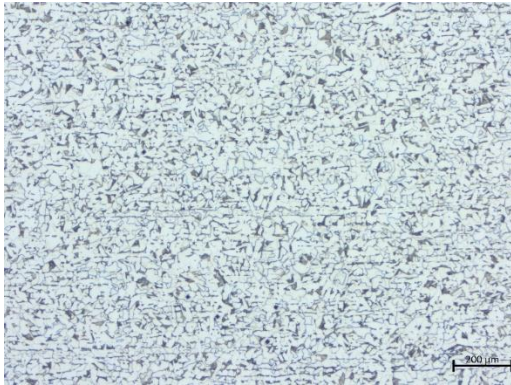
Figure 7 Lamellar ferritic/pearlitic structure at lower magnification than in Figure 6

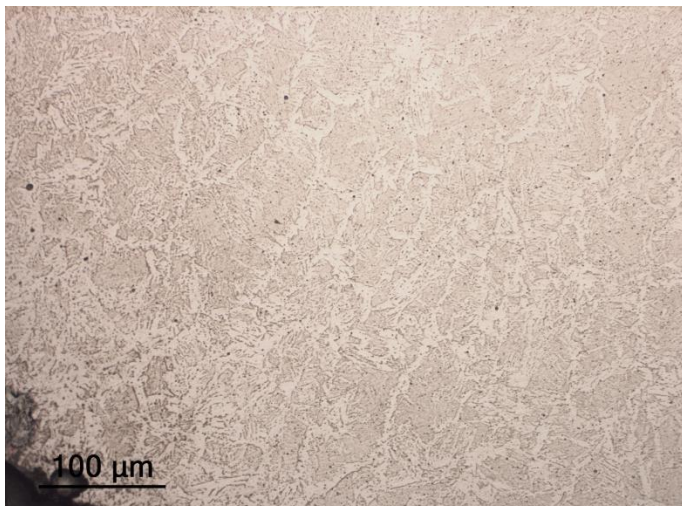
The variation in microstructure across the interface is clearly visible in Figure 11, where the ferritic/pearlitic structure is visible in the bottom left corner, the pearlite becomes coarser and then a very fine grained structure is observed in the middle. In the upper right region a ferritic pearlitic region with ferrite along former austenitic grain boundaries, see Figure 12, is observed with a pearlitic interior. The former austenite grain size is in the order of 100 μm .

Figure 12 Microstructure in the ridge cap.

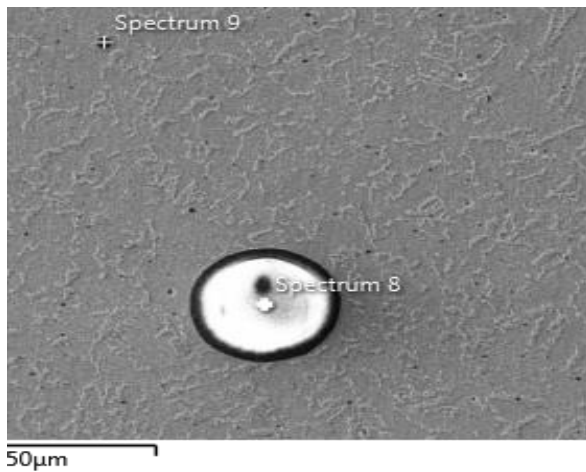
EDS point analysis was conducted for two of the spherical particles, cf. Spectrum 8 and 9 in Figure 15. The results are shown in Figure 16 and 17.

Figure 15 EDS point analysis was conducted for the two particles marked Spectrum 8 and Spectrum 9.

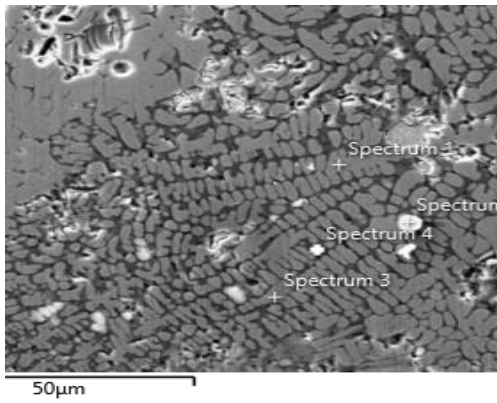
EDS analysis from the dendritic phase, e.g. spectrum 1 and 3 in Figure 20, reveals that the phase contains the amount of elements according the table listed in Figure 21. Fe, O, Mn and C are the main elements in this phase. O and C is usually difficult to quantify by EDS, but it is reasonable to believe that the elements are present within in the phase. It is reasonable to believe that this is melted iron oxide, and the temperature is estimated to be above $1200 \text{ }^\circ\text{C}$.

Figure 20 The region of interest where the EDS analysis was performed.

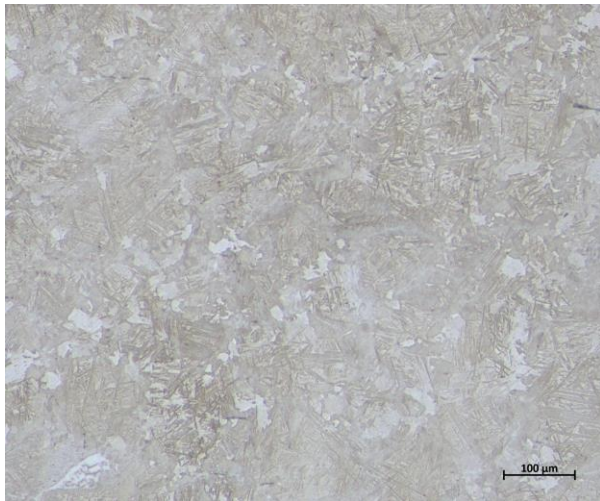
Mild steels are difficult to harden due to the low carbon content. To get an idea of the microstructure and obtainable hardness, a small sample was taken from the reference sample and put in a 1200 °C hot furnace. The sample was kept there for 10 minutes and then quenched in 13 °C cold sea water. The average hardness of 6 measurements was found to be HV1 295. The microstructure with a mixture of ferrite and martensitic needles is seen in Figure 31. None of the observed microstructures in the investigated plate is similar to the hardened microstructure.

Figure 31 The microstructure of a hardened reference sample.
